Ceramic Cup

“New Refractory Strategy for Improved BF Campaign Life”

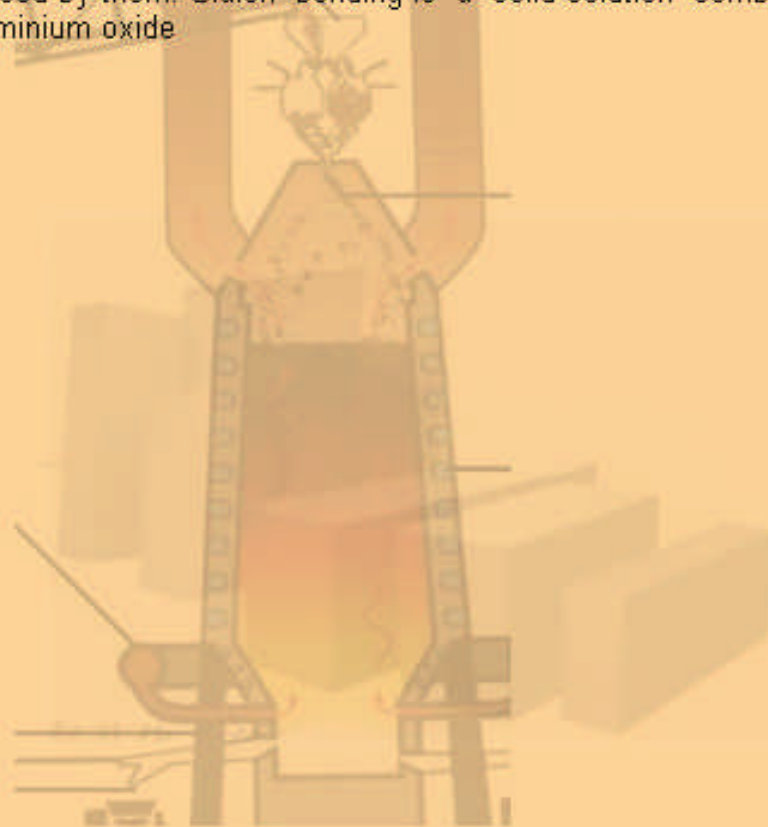
A study made by **Thyssen Krupp Stahl AG Germany**, suggested that use of Ceramic Cup of "**corundum with Sialon bonding**" completely eliminated the Hearth breakouts being experienced by them. Sialon bonding is a solid solution combination of silicon nitride and aluminium oxide

Since a high level of heat flow is an undesirable outcome from the energy viewpoint, the installation of a ceramic bottom layer on the upper carbon stratum is a measure being taken. This terminates the premature wear in the bottom and reduces heat loss as a result of bottom cooling. This type of relining, using the Ceramic Solution emerged partly as a result of good experiences in Hearth life with these ceramic bottom layers. Ceramic bottom supplemented with ceramic material sidewall lining is the origin of CERAMIC CUP. Ceramic bricks used to protect the bottom coupled with their use to clad sidewalls, make the **CERAMIC CUP**.
